## Gas spring mounted at rocker arm casing and cover

**PrimeServ Customer Information**  
No. 377 / June 2017

All versions of the engine families  
L+V48/60, L+V51/60, L58/64, L+V40/54B

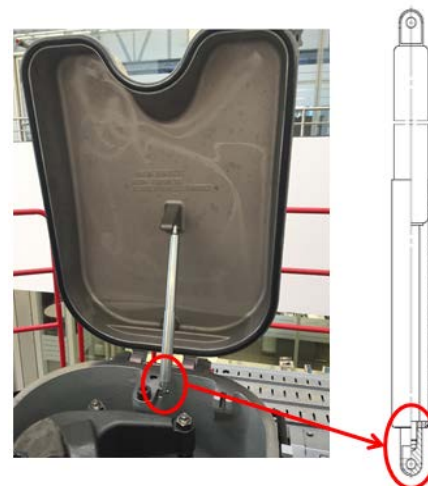
Recently we introduced a countermeasure to further improve the reliability of the gas spring. It affects the nut which is mounted at one end of the gas spring connecting it with the rocker arm casing. In future this nut will be additionally fixed adhesively on the gas spring piston to avoid turning off by itself.

- For safety reasons we suggest to wear a helmet.
- Check the gas spring visually for any abnormalities. Make sure that the pins connecting the gas spring with the cover and the rocker arm casing are in place, not damaged and fixed with splints. Ensure the existence and proper fixation of the aforementioned nut.
- Check whether the gas spring can move the cover upwards easily and is keeping it in that position safely. The cover must under no circumstances fall down by itself.
- In case of damaged components we recommend to replace them immediately.
- If the aforementioned nut comes loose please proceed as follows: Degrease and clean threads than allow drying. Clean threads with Activator 7471 and screw the nut in with Loctite 620.
