## Ridge Wear at Crankpin Journals

Replacement of SL2016-634/JNN

SL2017-647/JNN

May 2017

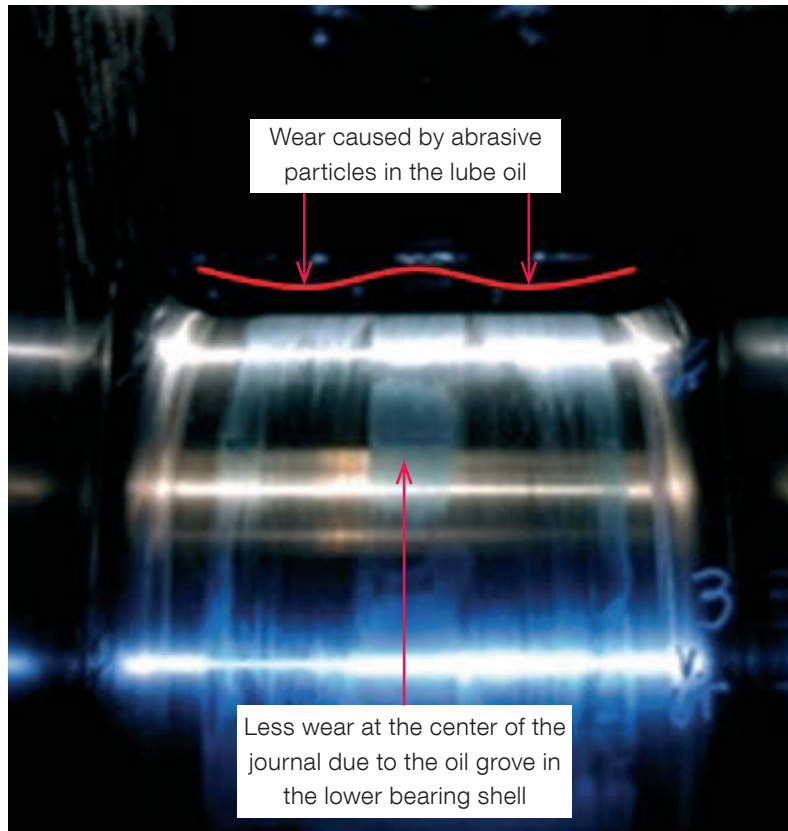
Ridge wear can be observed as wear on both sides of the centre of the crankpin journal. Ridge wear is often observed 15-60° after BDC, but can be extended to larger parts of the journal.

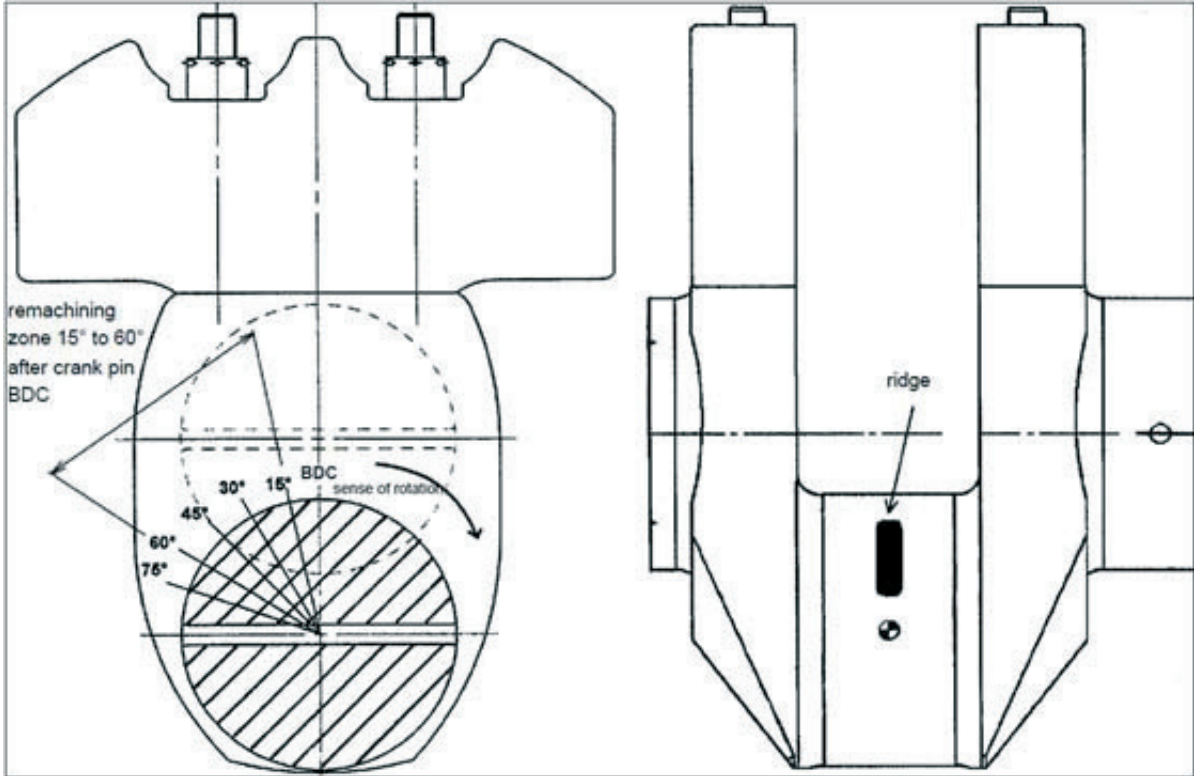
The sketch shows the location of the ridge wear in the highest loaded zone 15-60° after BDC.

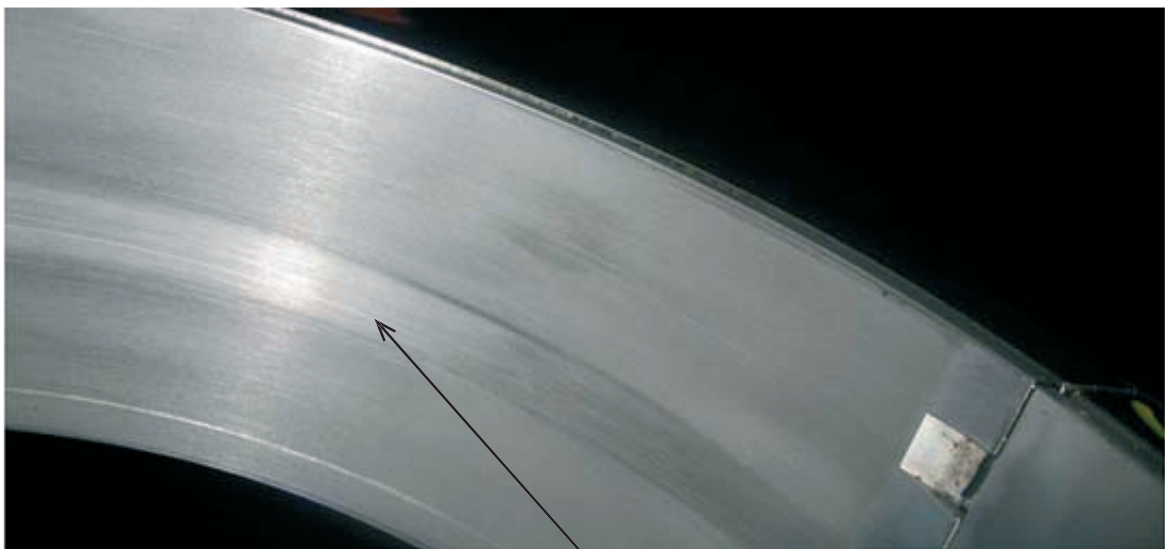
Careful inspection and judgement of the crankpin journals must be carried out whenever a new crankpin bearing is installed. If ridge wear is observed, this must be rectified before new upper and lower bearing shells are installed. In case rectification is not carried out, the bearing damage as shown in the following will occur after a few hours of operation. In case of continuous operation serious damage might occur to the bearing and journal.

Bearing shell with damage from ridge wear.

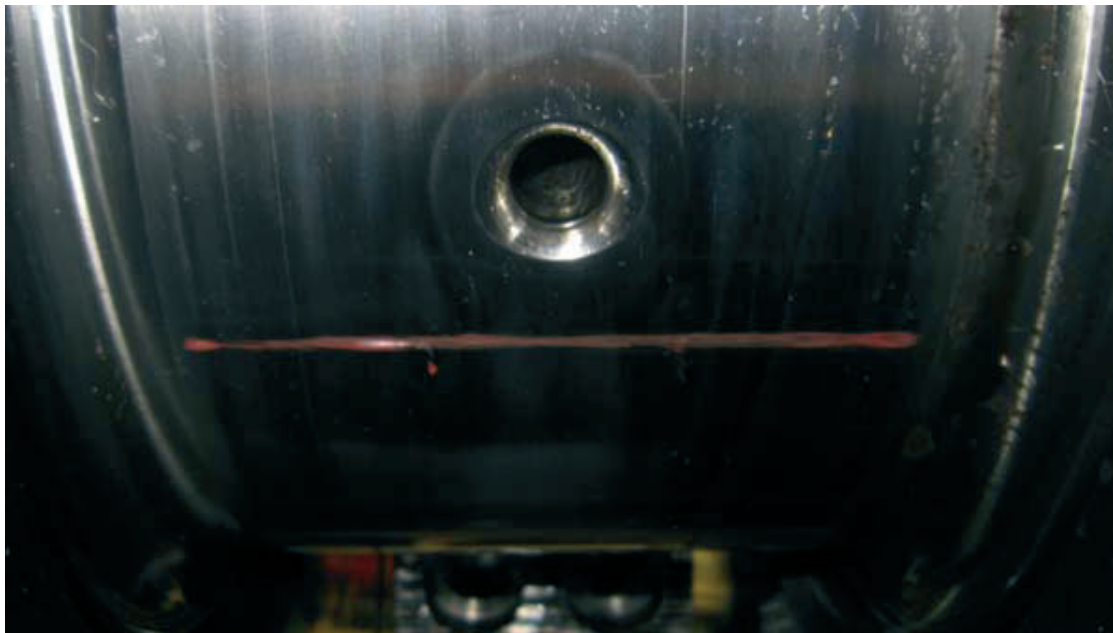
Contact test at a journal with no ridge wear, indicated by an unbroken line of the marking paste.

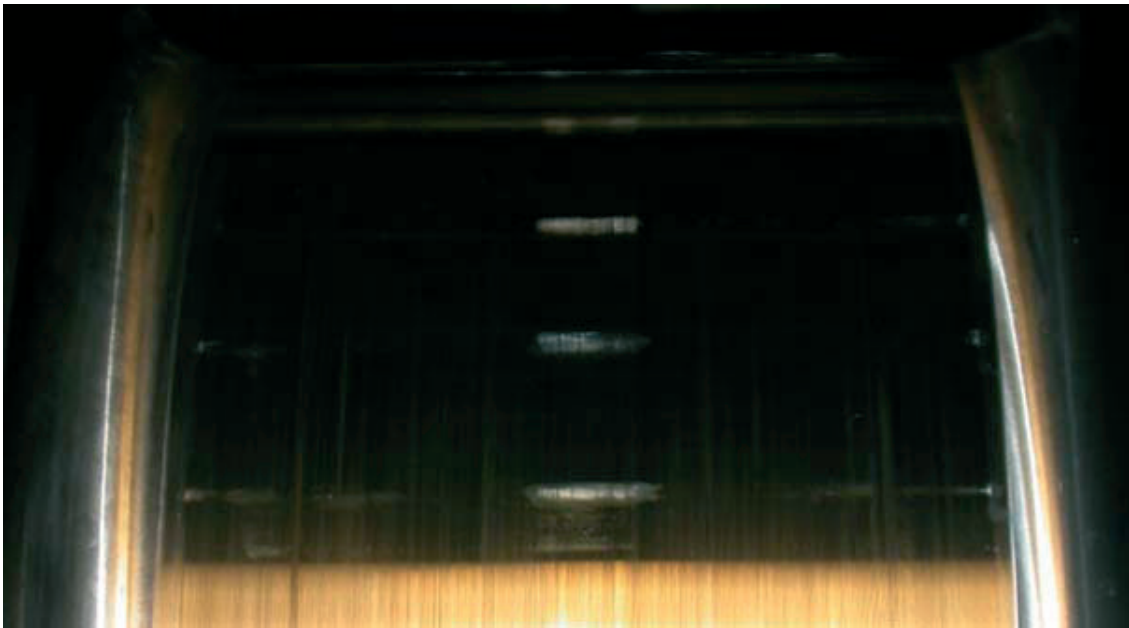
If there are indications of ridge wear, the line will be broken and look similar to the picture below. The broken line will look different from case to case since the depth and shape of the ridge wear will be different.

Example of journal with ridge wear – indicated by the broken lines of the marking paste.

Depending on the depth of the ridge wear, the affected journals must be polished or, in the worst case, machined to undersize.

< 5 micron, no action needed.

> 5-10 micron, polish the journal with a 400 grid emery cloth mainly in the centre of the journal to remove or bring the ridge wear below 5 micron.

> 10 micron, it is recommended to machine the journal to undersize (not available for L16/24).

If polishing is made, the ovality of the journal must be checked afterwards; the ovality may not exceed 3/100 mm.

After polishing the surface roughness must be within Ra 0,2-0,4.

After any polishing, it must be checked that no sharp edge is formed in the transition zone between the lube oil supply holes and the journal.
