New Gasket Material for Roller Guide Housing

SL2017-648/JNN
June 2017

Marine: L23/30H

Stationary: L23/30S

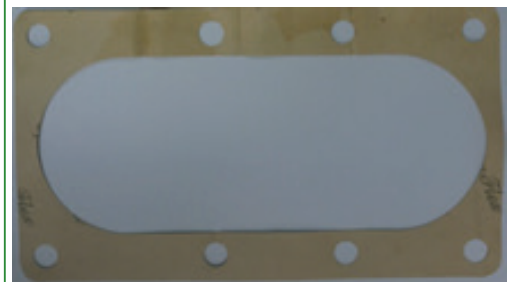
During operation, the roller guide housing is exposed to high dynamic forces causing some relative movement between the gaskets and the housing. This movement may in some cases form wear on the gasket surface, and thus the clamp force on the installation bolts may be reduced with the following risk of a roller guide housing incident. Variation in the quality of the applied paper gasket may also influence the above-mentioned situation. We have, however, not been able to pinpoint the exact root cause of the incidents.

Paper gasket

Furthermore, we recommend operators to replace the presently installed gasket, shown in Fig. 1, with Loctite 5699, shown in Fig. 2, at the first convenient opportunity, for example at next major overhaul of the GenSet. For the tightening torque, Molykote is added as grease for the roller guide housing installation bolts, whereas the tightening torque remains unchanged at 60 Nm.

As a preventive measure until the above new gasket material has been introduced, we recommend to retighten the roller guide housing every 1000 running hours.

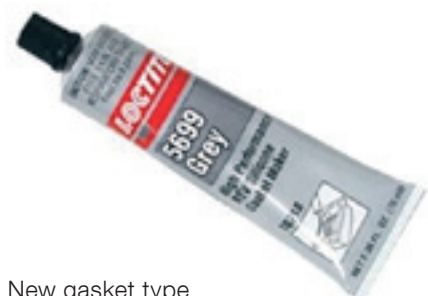
New gasket type

As a precautionary measure against incidents on new engines, we have updated our standard design by replacing the paper gasket with liquid gasket Loctite 5699. We attach the updated plate P50801-20 in which the gasket, item 232, has been replaced with glue (Loctite 5699).
