## Ridge Wear at Crankpin Journals

Replacement of SL2016-634/JNN

SL2017-647/JNN

May 2017

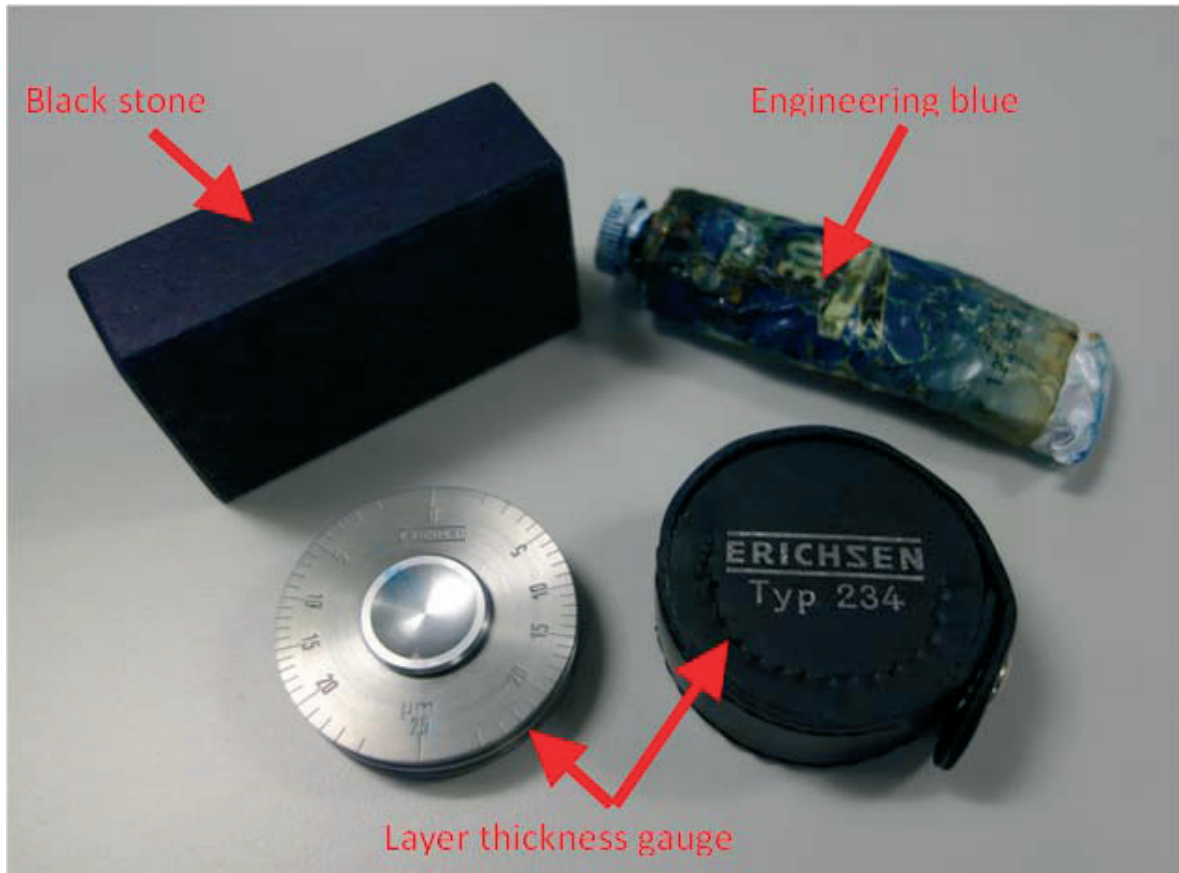
Example of a tool kit used for checking for ridge wear

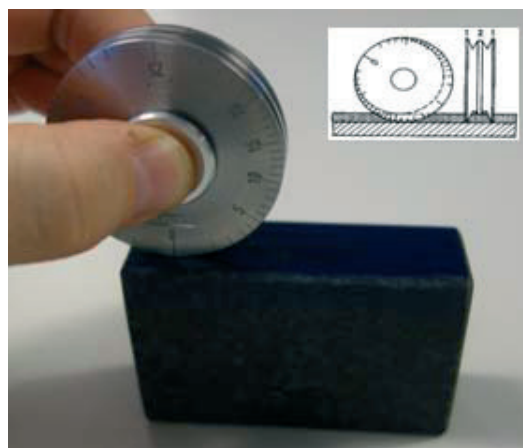
The layer thickness of the marking paste is checked before the test is carried out.

To measure ridge wear on a journal, blue paste should be applied to the black stone in a thin uniform layer, and it is best applied with a sponge. The thickness of the layer should be 4-5 microns. Use the layer thickness gauge to check the thickness before the contact test at the journal is carried out.

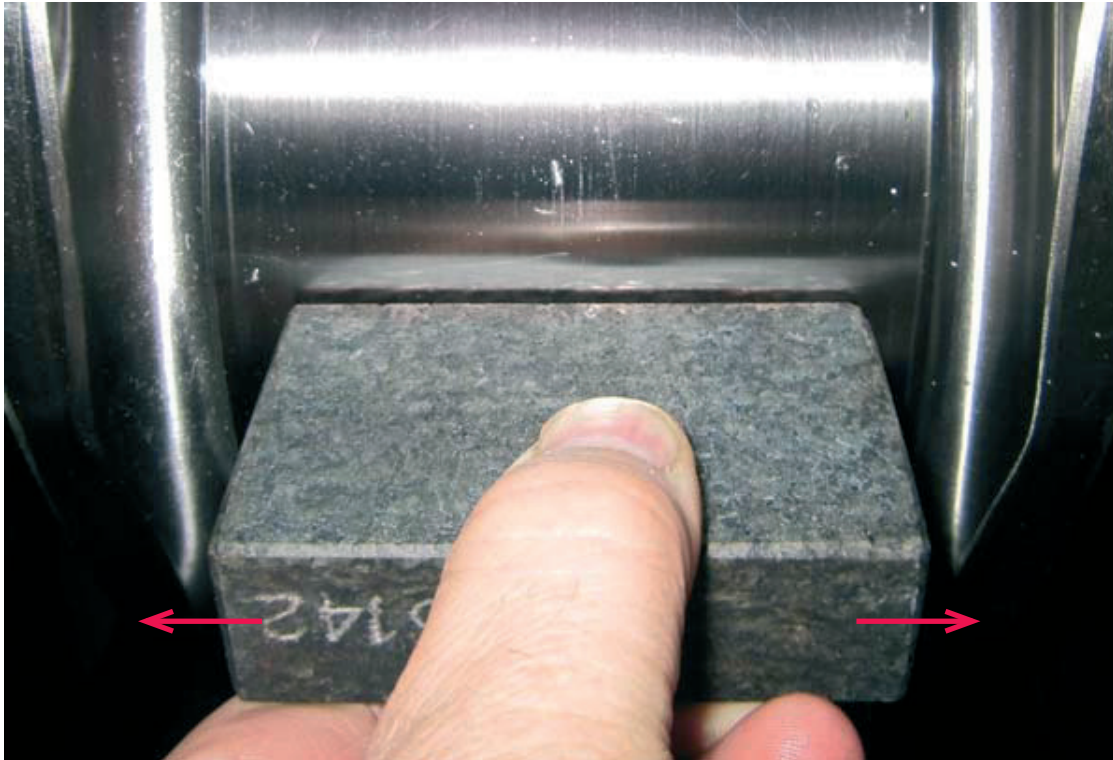
Test the journal by moving the stone back and forth on the journal to determine possible ridge wear on the journal.

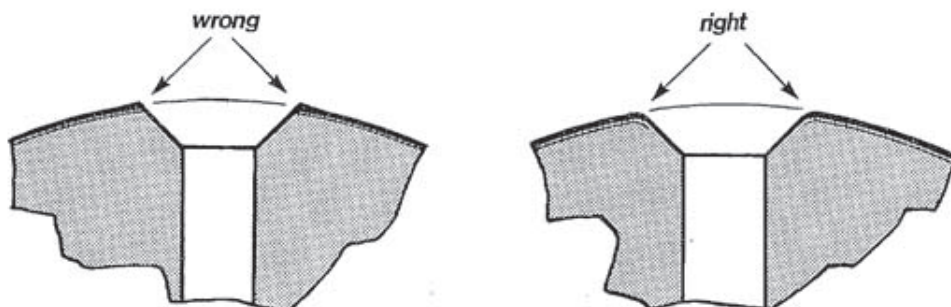
After any polishing, it must be checked that no sharp edge is formed in the transition zone between the lube oil supply holes and the journal.

If polishing is made, the ovality of the journal must be checked afterwards; the ovality may not exceed 3/100 mm.

After polishing the surface roughness must be within Ra 0,2-0,4.
